**THE STRATIGRAPHY AT THE SITE OF PSALMODI
DEPARTMENT OF GARD, FRANCE
FINAL REPORT**

**BY
SUSAN-ALETTE DUBLIN PH.D., R.P.A.
AND
TAYLOR L. ZANERI M.A.**

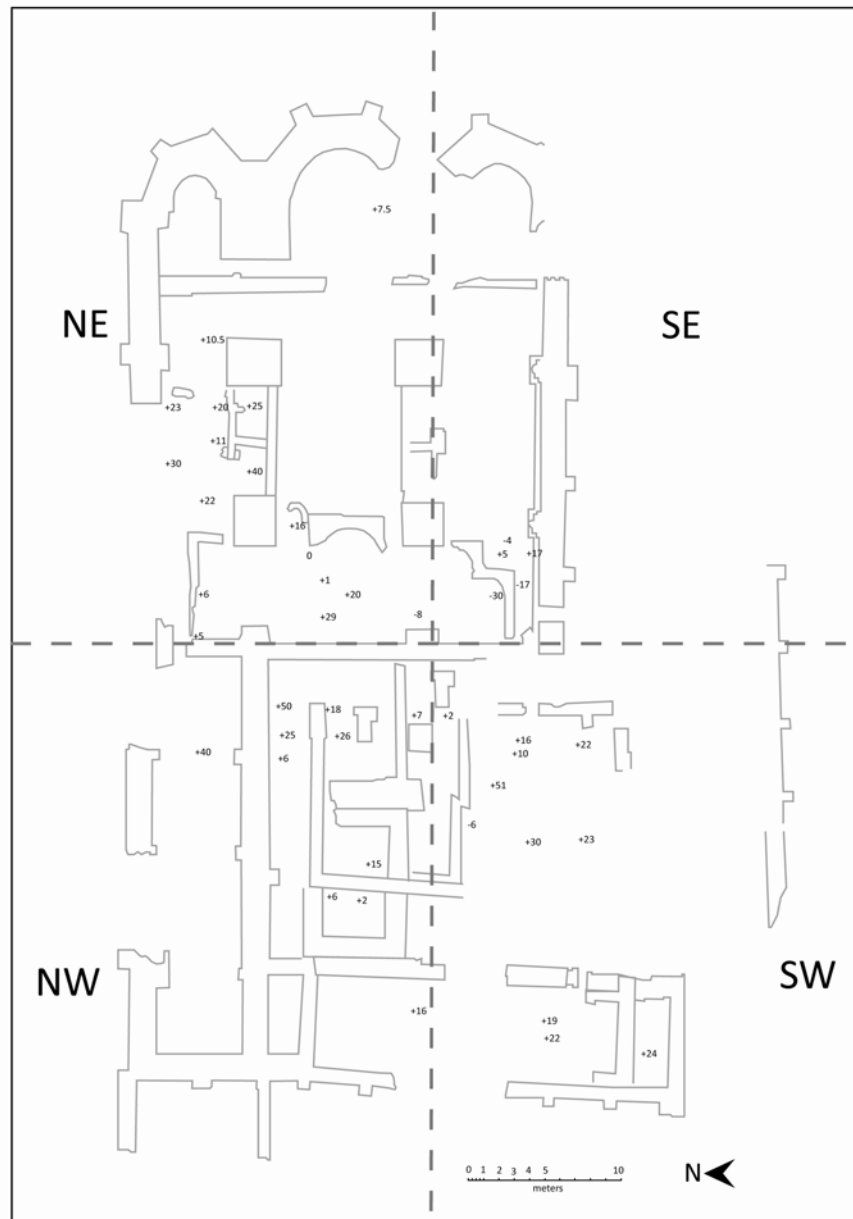
Figure 3.3 Elevations and spatial distribution of substrate.

The substrate, or *poudingue*, is characterized by a hard bumpy surface, yellowish-brown in color, which incorporates water worn pebbles, limestone concretions, and gravels. In some areas, it is scoured out into small circular depressions (Dublin and Zaneri 2008:5; Yoon 2010), while in others, it forms small humps. Table 3.1 summarizes the characteristics of the substrate as encountered on the site, while figure 3.3 shows its distribution. In several locations, the substrate is overlain by a reddish-yellow or yellowish-brown clayey silt, essentially *poudingue* that had decayed due to dampness or inundation. Both the *poudingue* and the decayed *poudingue* are culturally sterile. The mean elevation of the substrate is 14.8 centimeters above the site datum, or approximately 260 cm. above sea level. Both the standard deviation and the range are relatively high, but this would seem to reflect the bumpiness of the surface rather than an overall trend. Three-quarters (78.3%) of the recorded elevations fall within a normal range around the mean, while fully 95.7% are within one standard deviation of the mean. Lower elevations tend to cluster in the southeast quadrant, while high points are scattered across the western sector of the site. The mean elevation of the western half of the site is 11 centimeters higher than the mean in the east (10.4cm.), supporting a general impression of an overall level surface (albeit bumpy) with a slight slope toward the east.

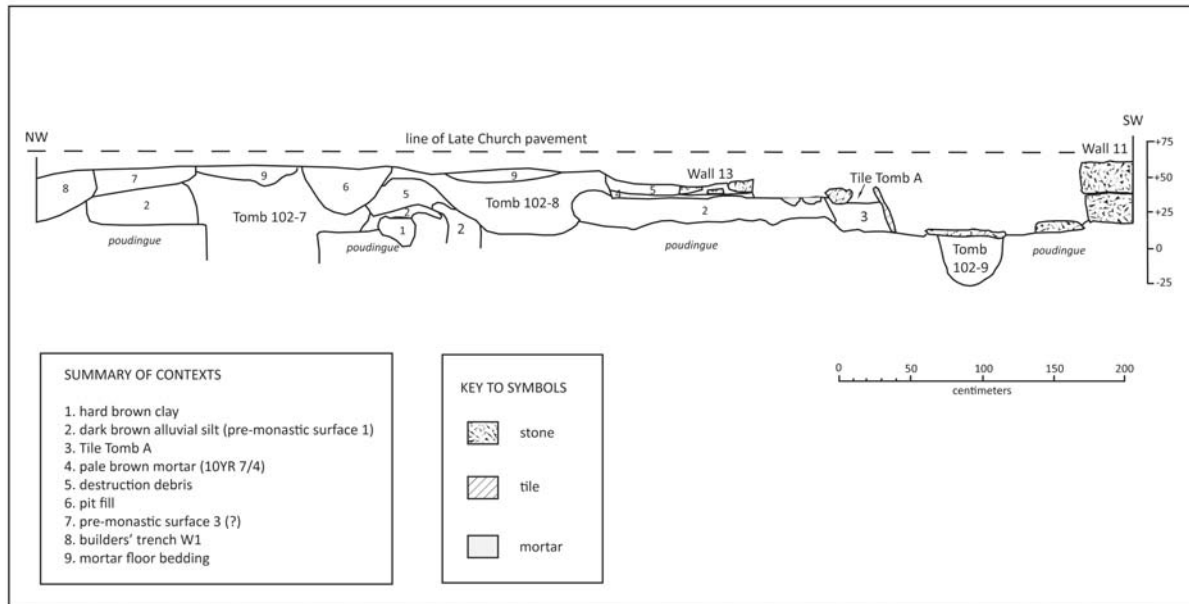
Figure 4.5 West-facing profile of trench 25/102 showing the stratigraphic positions of tile tomb A and tombs 14-1, 14-2, and 14-3. (after Young in Stoddard 1983).

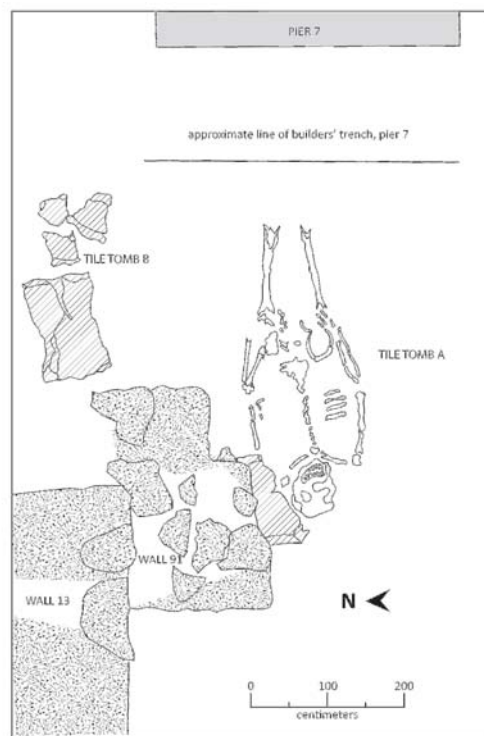
Figure 4.6 Plan view, Tile Tomb A, Trench 102 (after Stoddard 1988:18-19).

<i>Tomb #¹</i>	<i>Type</i>	<i>Stratigraphic information</i>	<i>Reference²</i>
TT-A	tile tomb	see figure 4.6; cut by builders' trench W7; cut into surface 1 with remains resting on substrate	Stoddard 1978
TT-B	tile tomb	see figure 4.6; cut by builders' trench W7; cut into surface 1 with remains resting on substrate; overlain by surface 2	Stoddard 1978
102-1	slab-covered	NW orientation, 55° N of grid E	Stoddard 1983
102-2	slab-covered	NW orientation, 55° N of grid E; cut into surface 2; overlain by rubble, burned daub, and charcoal	Stoddard 1980
102-3	slab-covered	NW orientation, 55° N of grid E; cut into surface 2	Stoddard 1980
102-4	slab-covered	NW orientation, 55° N of grid E	Stoddard 1981
102-5	slab-covered	NW orientation, 55° N of grid E; cut into surface 2	
102-6	slab-covered	NW orientation, 55° N of grid E; cut by W17	Stoddard 1981
102-7	anthropomorphic	E orientation; cut through W44/91	Stoddard 1979

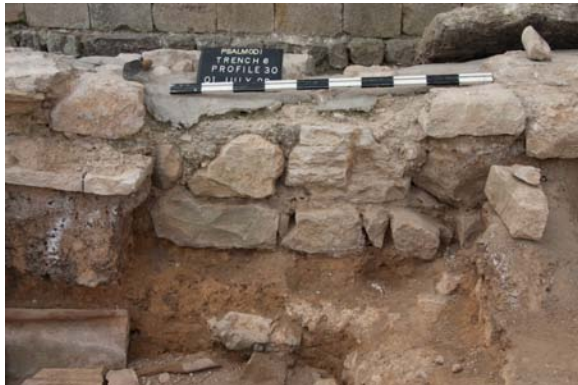
Figure 5.2 Masonry break in W83, Early Church. (Photograph by Robert Dublin 2009)

irregular stones seen in the photograph, figure 5.2. A builders' trench associated with these upper courses (figure 4.10, context 27.2) was cut down to the juncture of course 1 and course 2, level with the masonry break. The small tile tomb 6B abuts W83; unlike tile tomb 6A, it was associated with the Early Church. The location of the west wall of the transept remains unknown. However, the remains of what appears to be the rough cut face of W83 can be seen under the footings of the closing wall of the Late Church (figure 5.3). It is likely that the northward turn of the transept is probably buried under, or incorporated into that later wall.

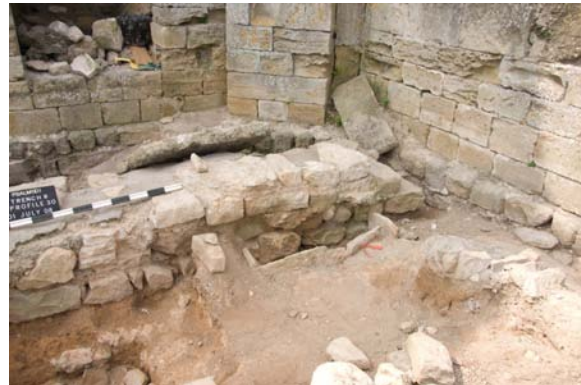
Figure 5.3 W83 extending under closing wall. (Photograph by David Yoon 2009)

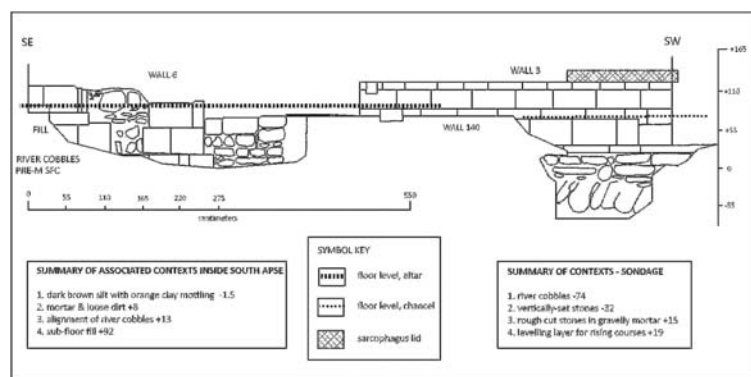
6.3 Elevation drawing, walls 3 and 6, Late Church.

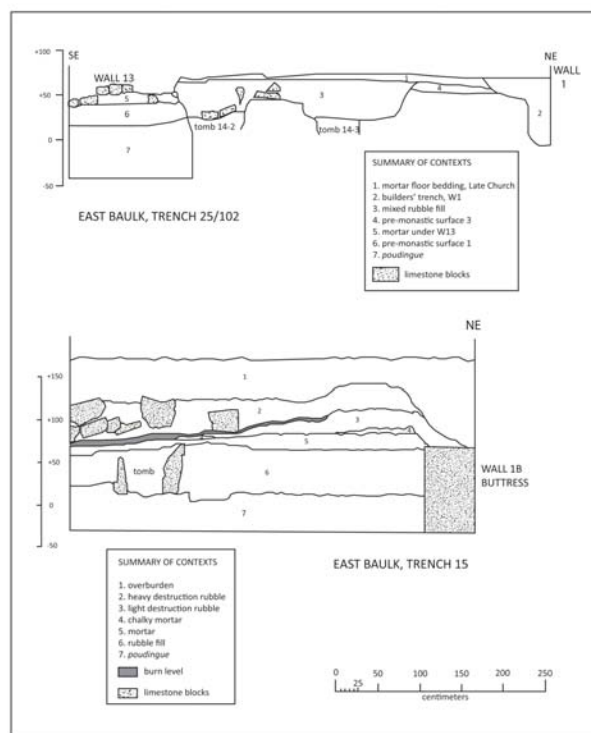
Figure 6.4 Comparative stratigraphy south of Walls 1 and 1B. (after Young in B.W. Stoddard 1989)

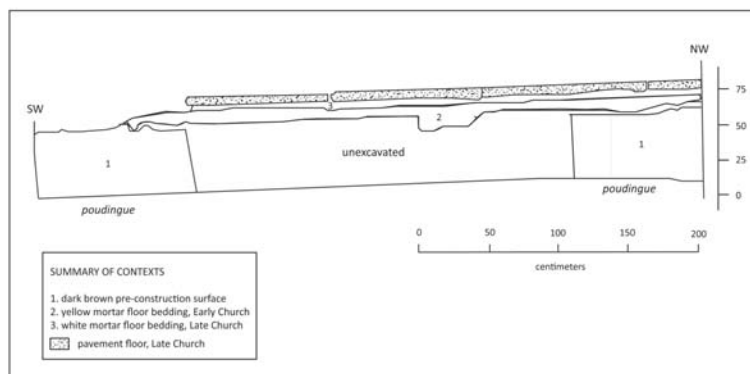
Figure 6.5 East baulk of Trench 99, showing superimposed floor bedding levels. (After Young in B.W. Stoddard 1989).

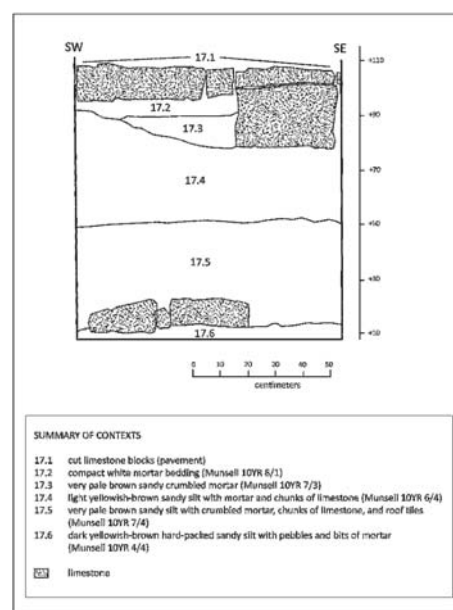
Figure 6.7 South-facing baulk, Trench 92

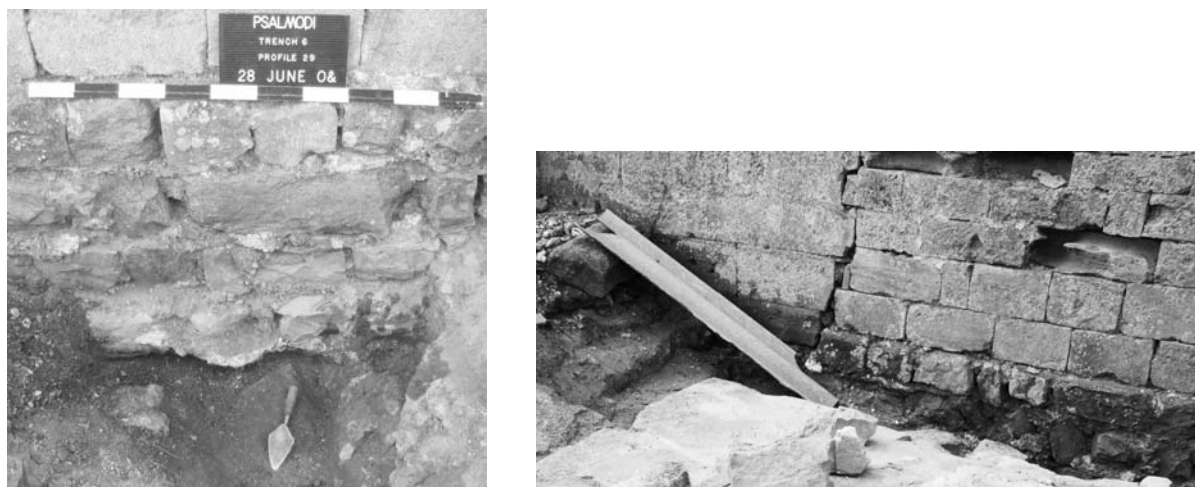
Figure 6.11 Abutment pattern, south wall extension, and underlying foundation.
(Photographs by David Yoon 2008)

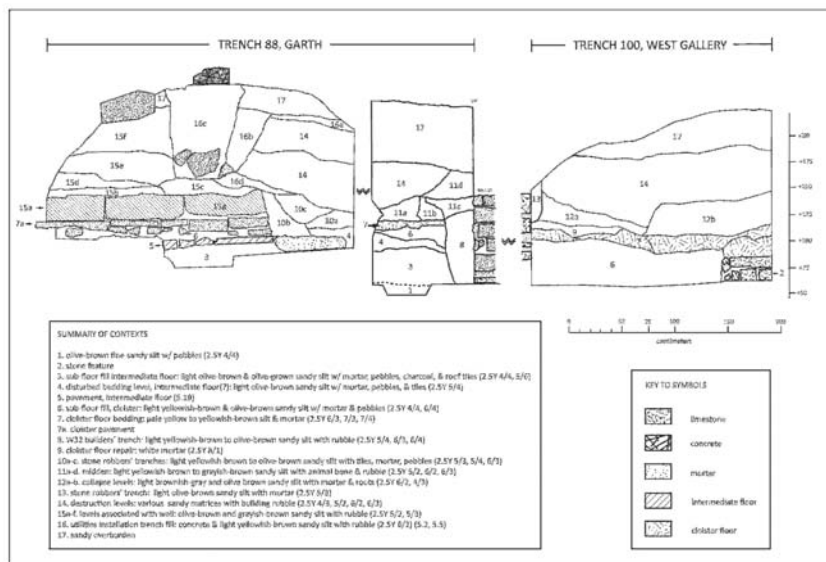
Figure 7.2 South baulks, Trenches 88 & 100, garth & west gallery of the cloister.

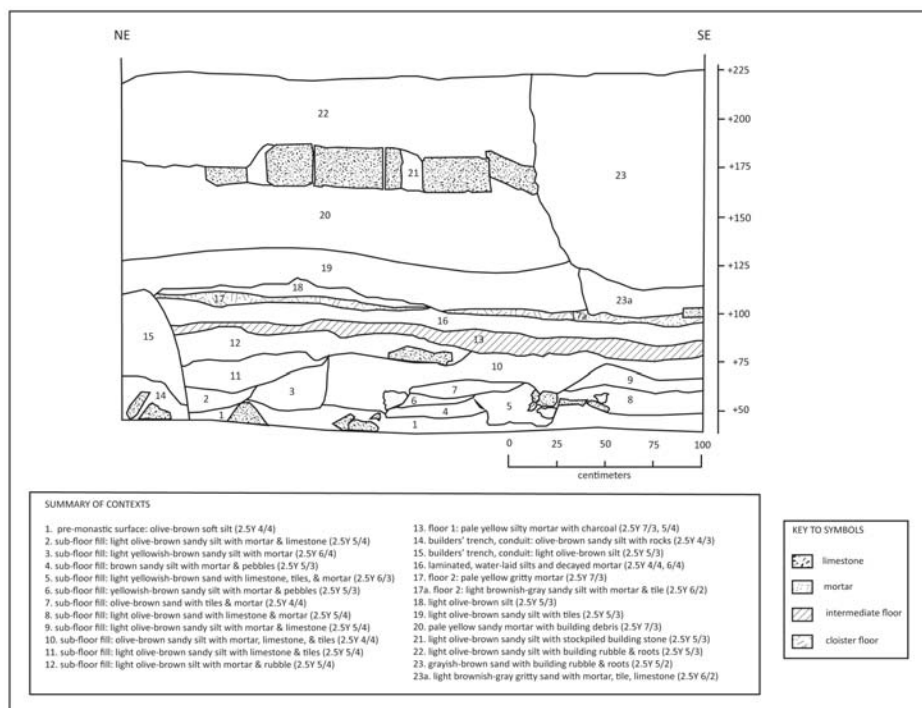
Figure 7.4 East baulk, Trench 56, west gallery of the cloister.

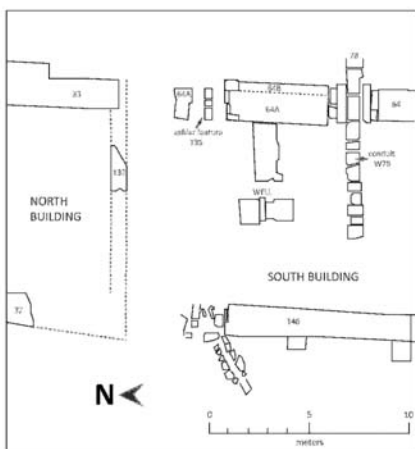
Figure 8.6 The conjectural layout of the water control system.

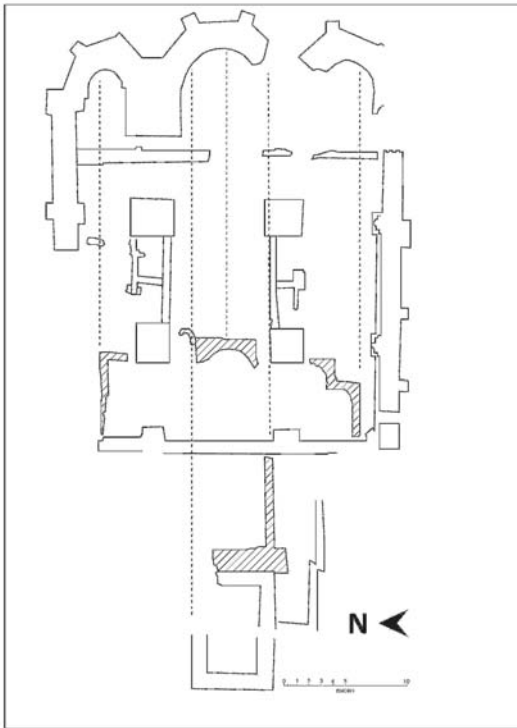
Figure 11.3 Juxtaposition of Early and Late Churches.
